FA8903-08-D-8786 TO 0011		North Wind, Inc		Title II Oversight Hill AFB Housing Area PCB Remediation OU 13	
Project Number: KRSM20110835		(Remediation Contr is Cape)			
Contract Number / Task Order Number		Contractor		Project Title / NWI Project No.	
1		04/07/11		Hill AFB, UT Freedom Terrace Housing Area OU-13	
CQC Report Number		Date or Time Period		Location and Team

Hill AFB Housing area OU-13. PCB excavation areas marked at 4111 B North Bridge Circle

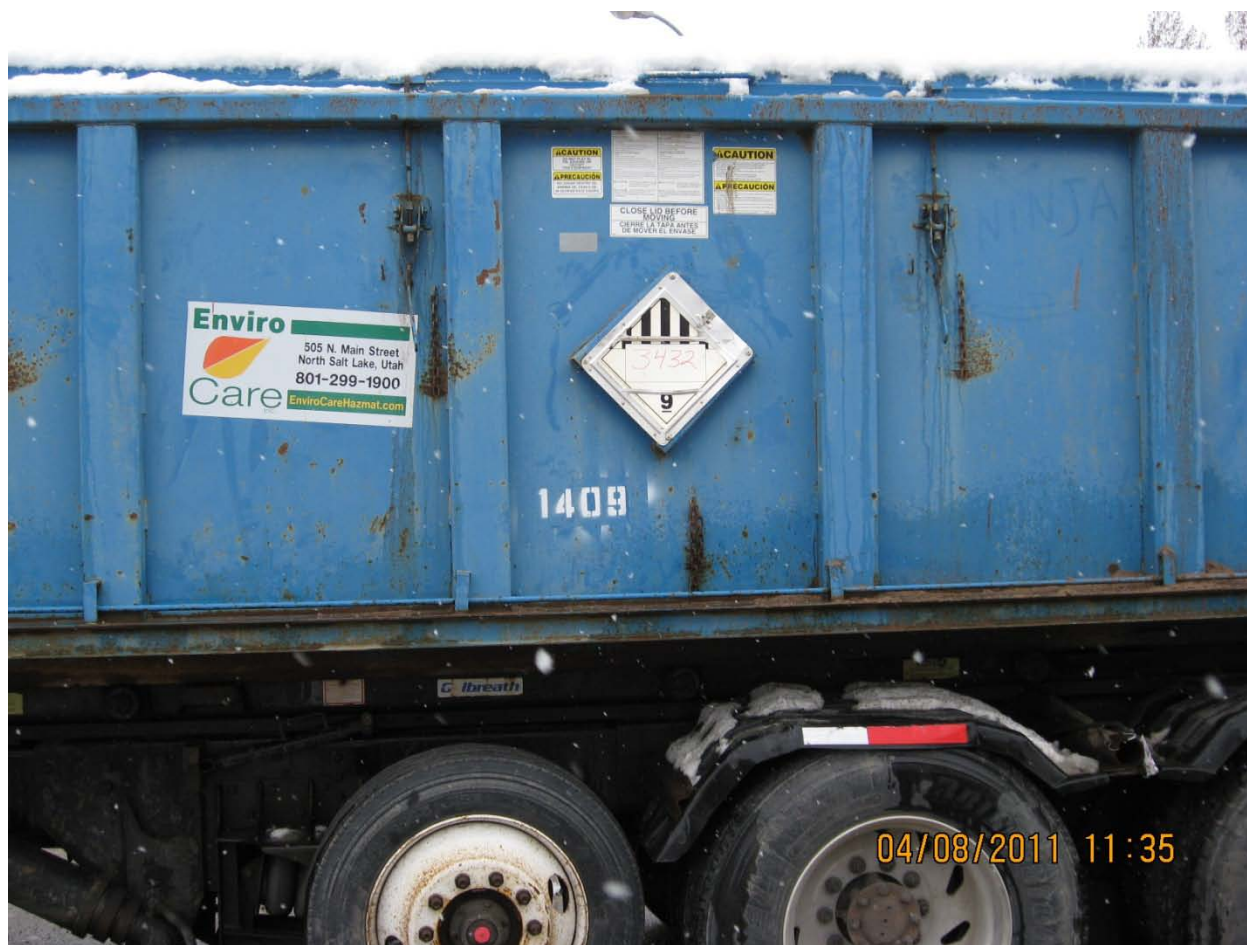
Date	Time	Direction of View
04-08-11	1135	W

Hill AFB Housing area OU-13. No. 3 end-dump loaded with PCB contaminated soil and covered at 4111 B North Bridge Circle.

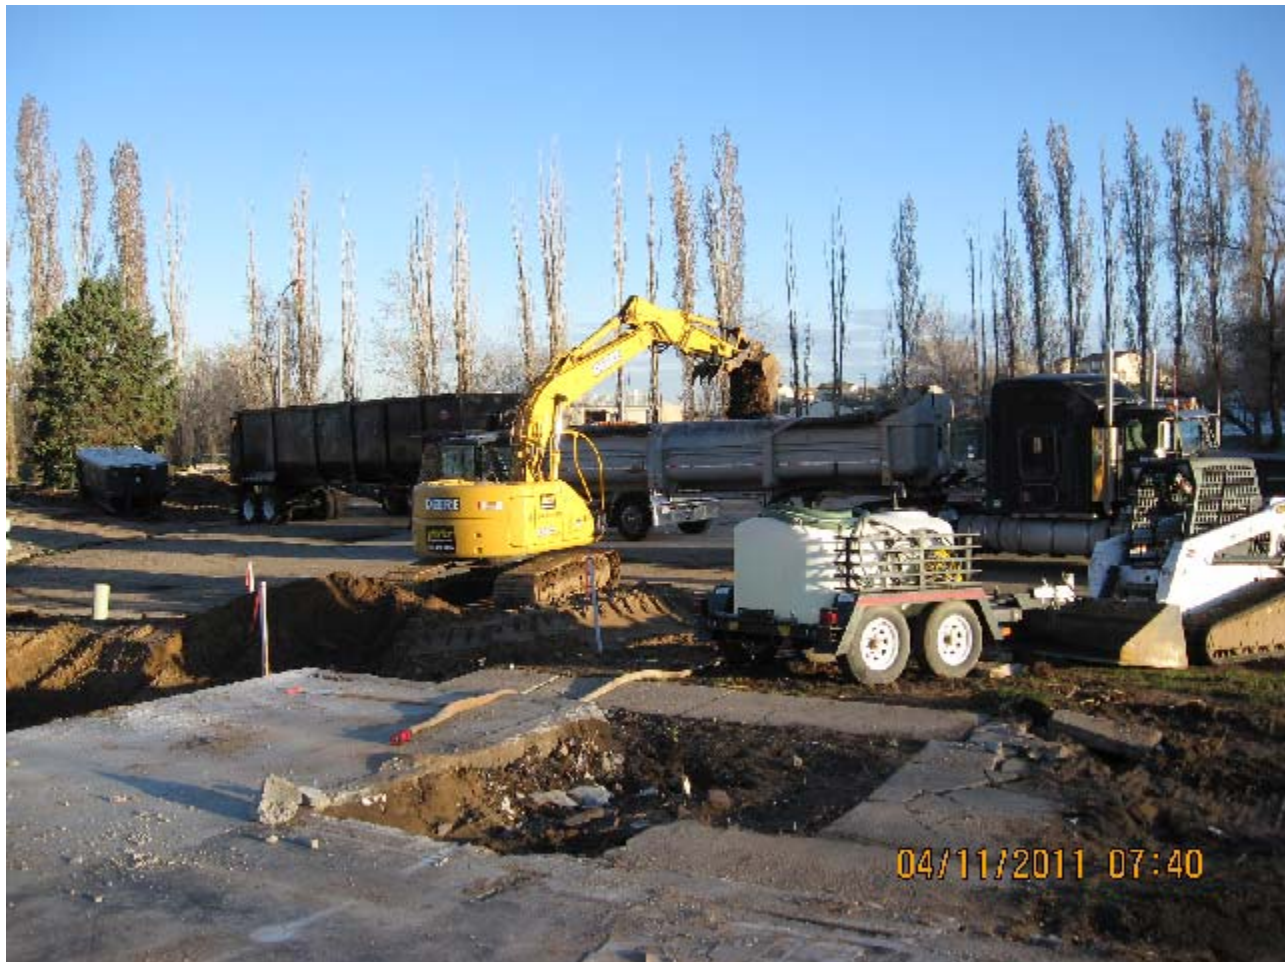
Date	Time	Direction of View
04-11-11	0740	NW

Hill AFB Housing area OU-13. Loading #4 end-dump truck with soil from excavation at 4111 B North Bridge Circle.

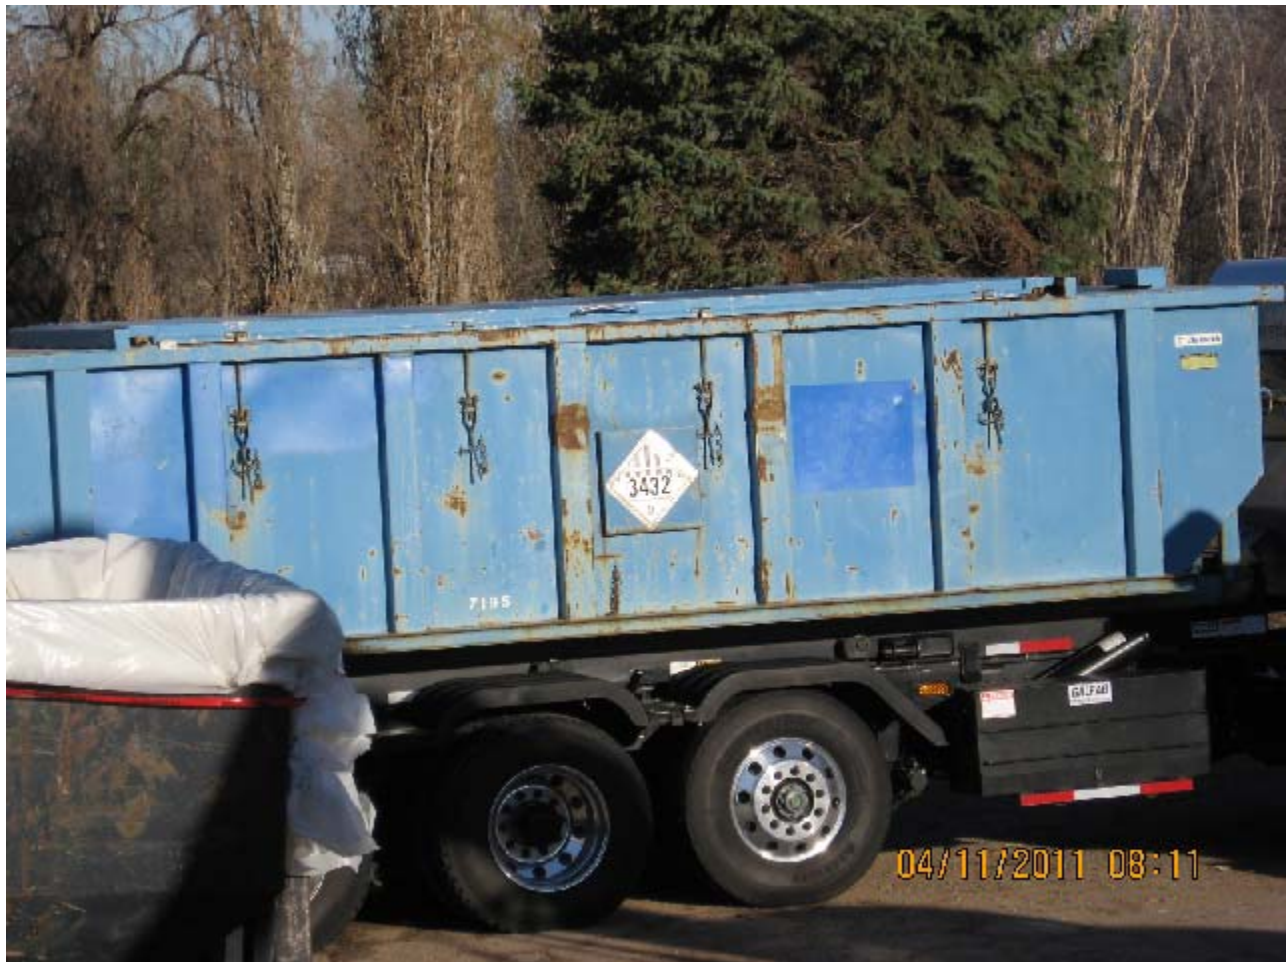
Date	Time	Direction of View
04-11-11	0811	NW

Hill AFB Housing area OU-13. Loading up filled roll-off box No. 2 at 4111 B North Bridge Circle. This box was filled on 7 April 2011 with TSCA regulated PCB contaminated soil excavated from the 4111 B site.

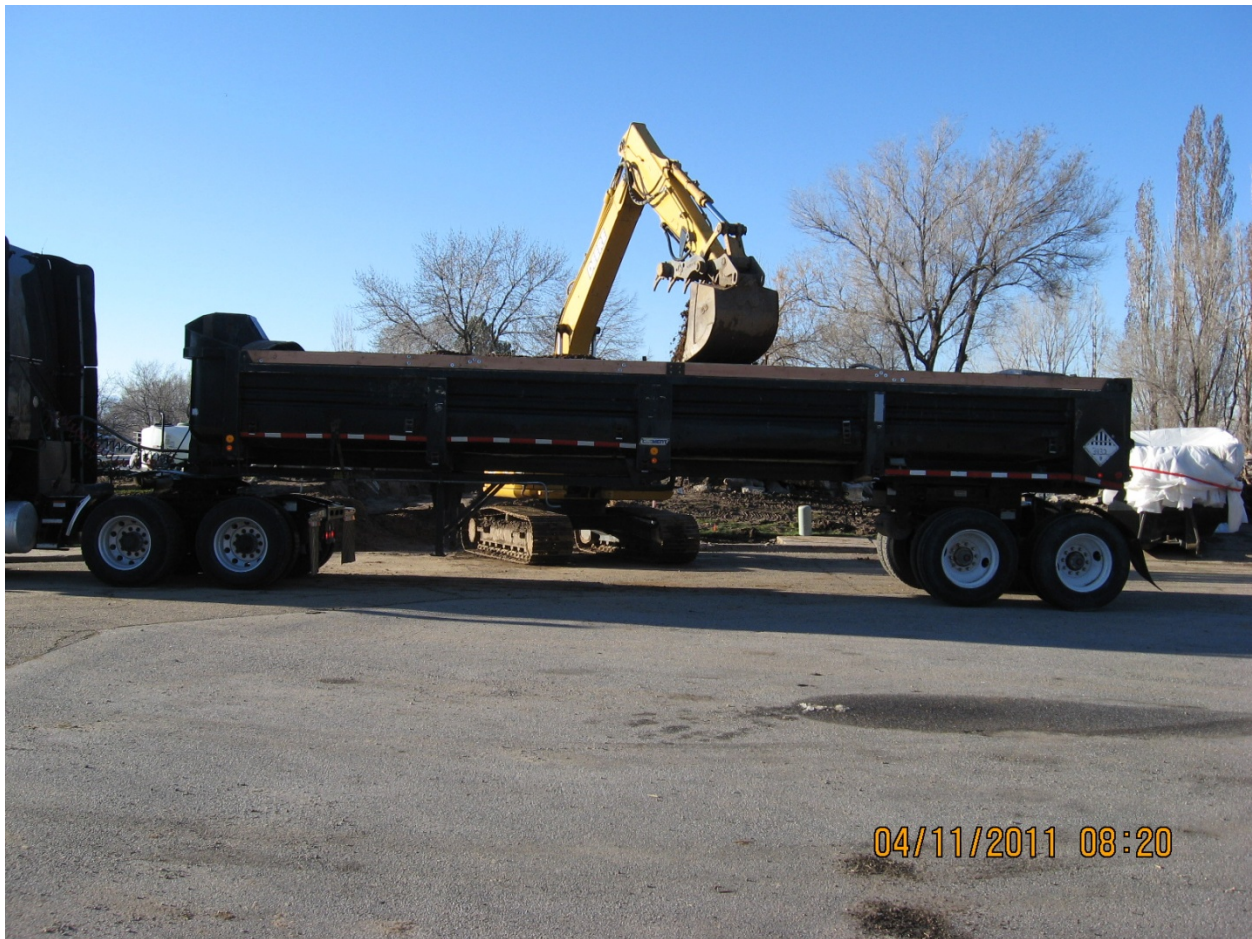
Date	Time	Direction of View
04-11-11	0820	S

Hill AFB Housing area OU-13. Loading soil excavated from the 4111 B North Bridge Circle site into end-dump #5.

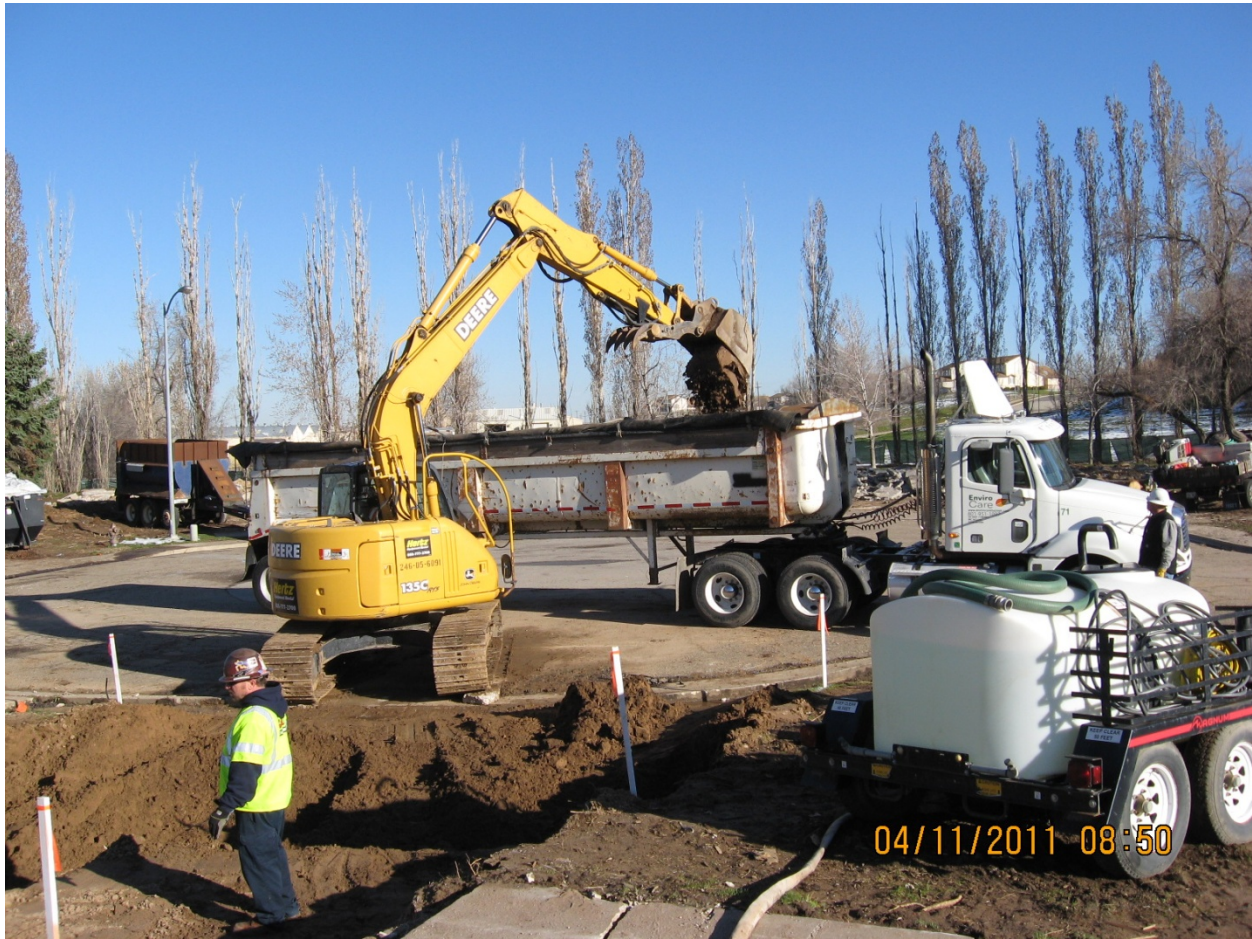
Date	Time	Direction of View
04-11-11	0850	N

Hill AFB Housing area OU-13. Loading soil excavated from the 4111 B North Bridge Circle site into end-dump #6.

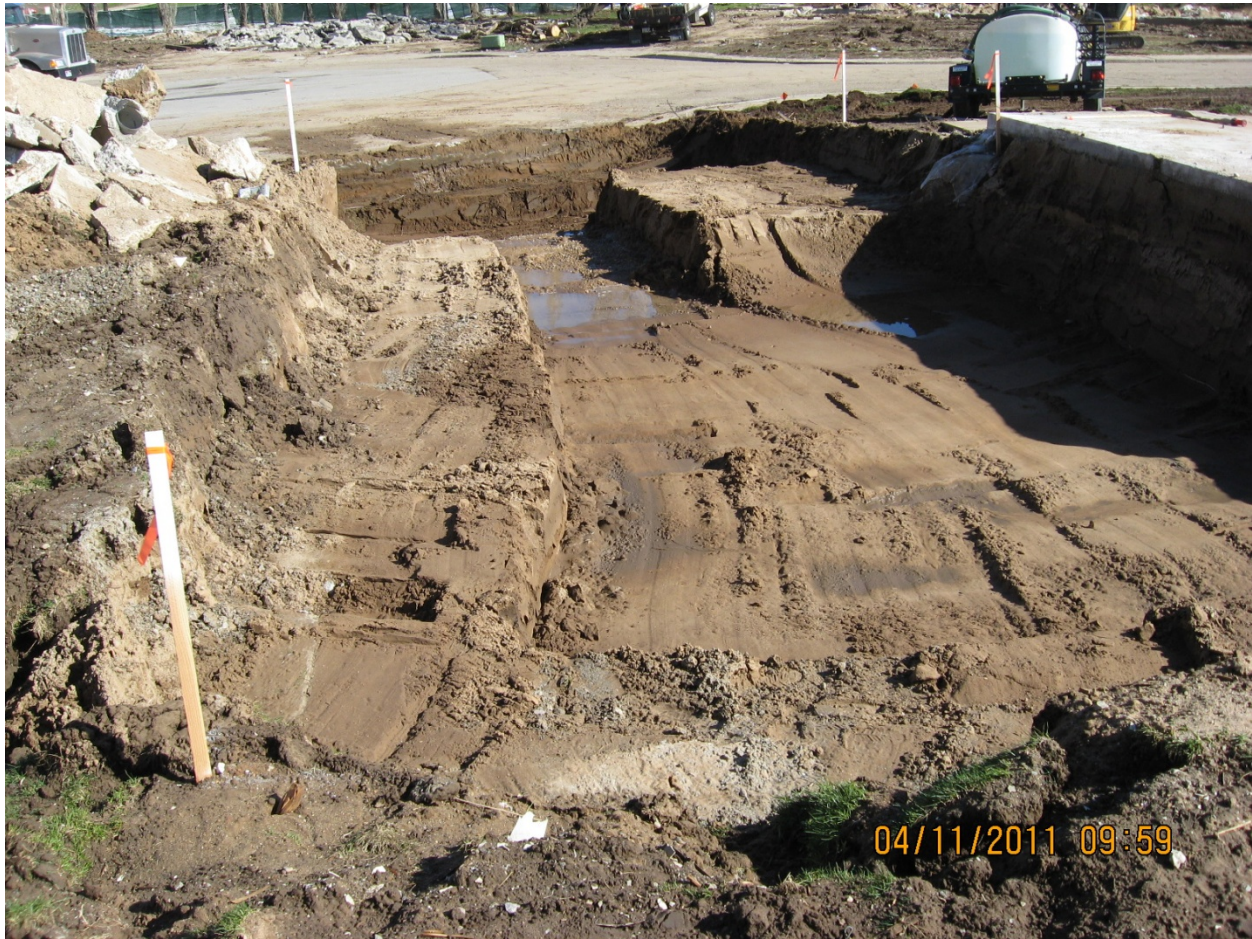
Date	Time	Direction of View
04-11-11	0959	N

Hill AFB Housing area OU-13. Excavation complete at 4111 B North Bridge Circle.

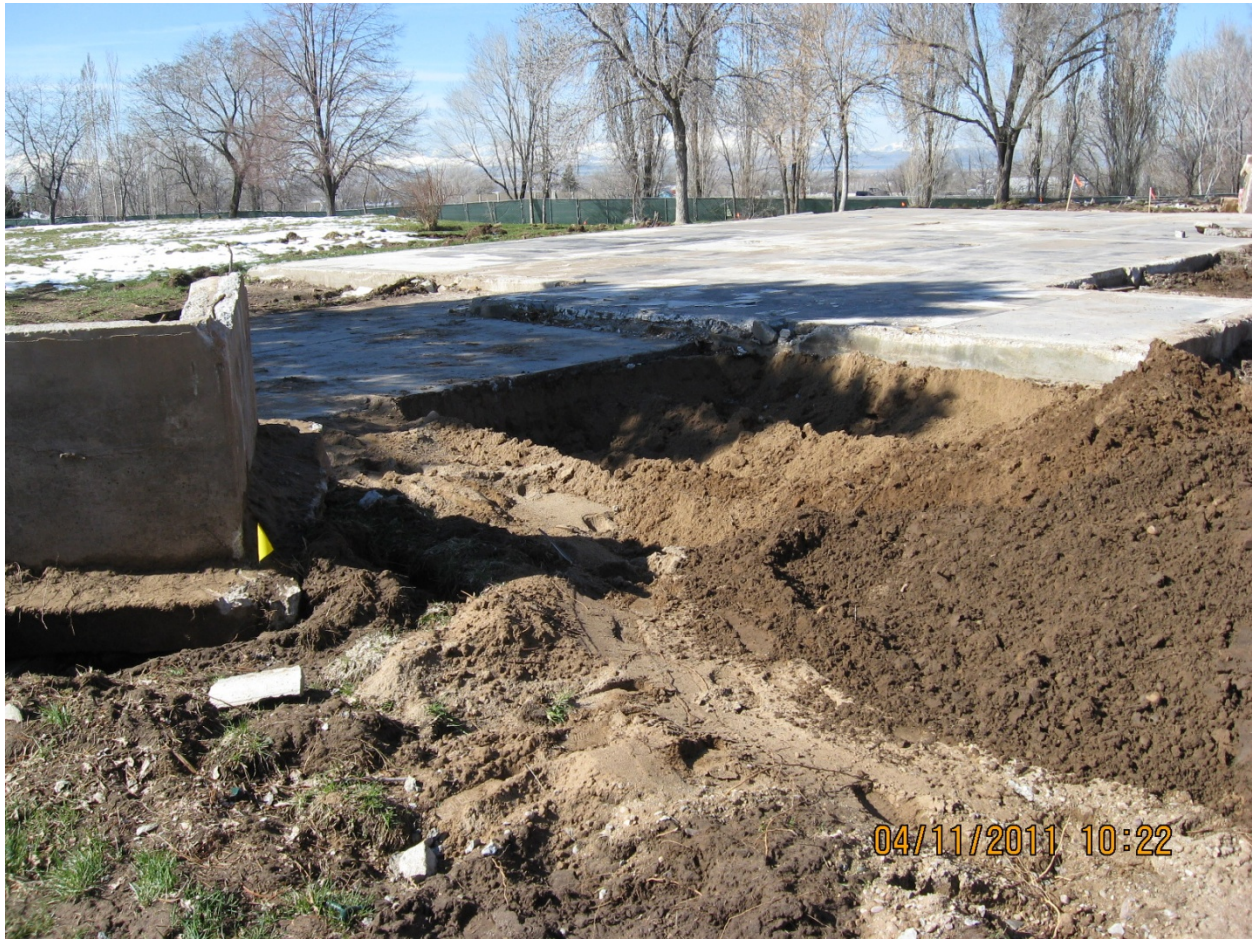
Date	Time	Direction of View
04-11-11	1022	SW

Hill AFB Housing area OU-13. Beginning excavation at 4111 A North Bridge Circle.
